# **Intel<sup>®</sup> Pentium<sup>®</sup> 4 Processor Specification Update**

Document Number: 249199-030

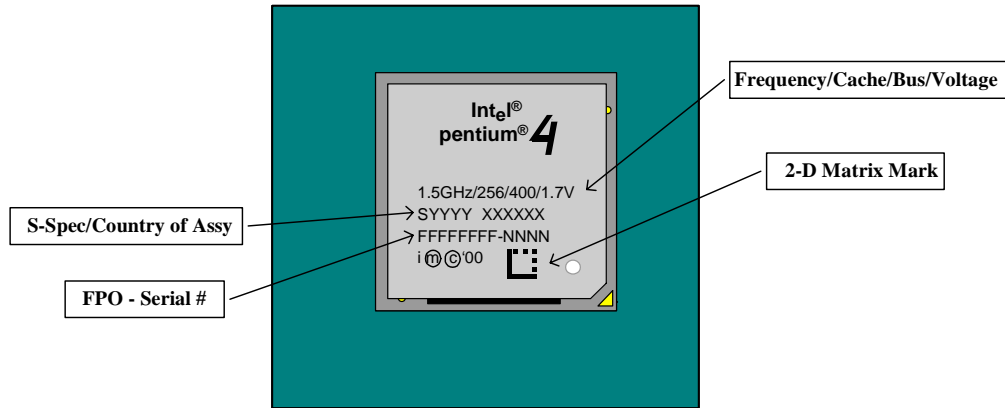
**Pentium 4 processor in the 423-pin package and boxed Pentium 4 processor in the 423-pin package markings**

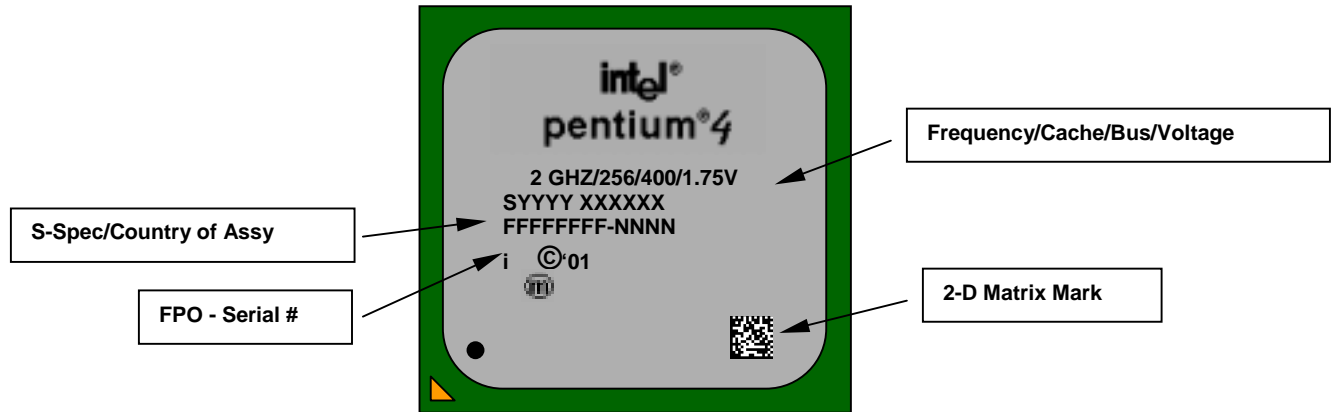
**Pentium 4 processor in the 478-pin package and boxed Pentium 4 processor in the 478-pin package markings**

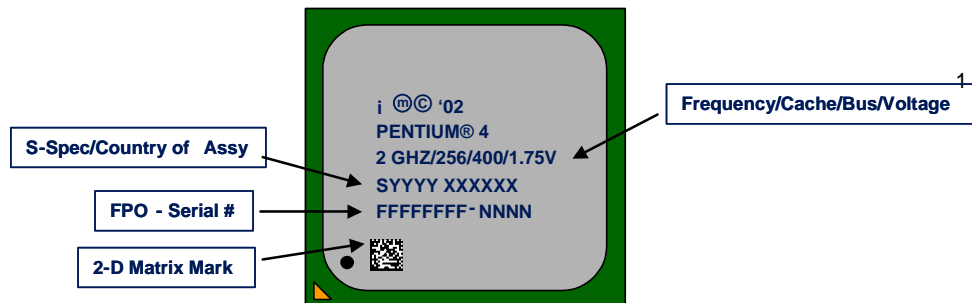
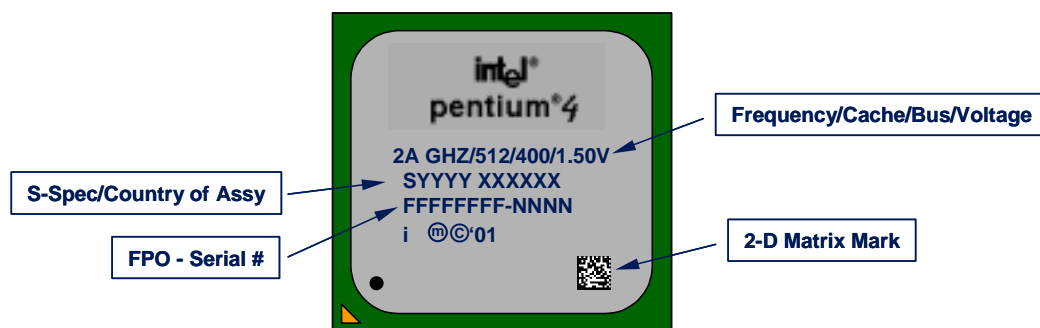
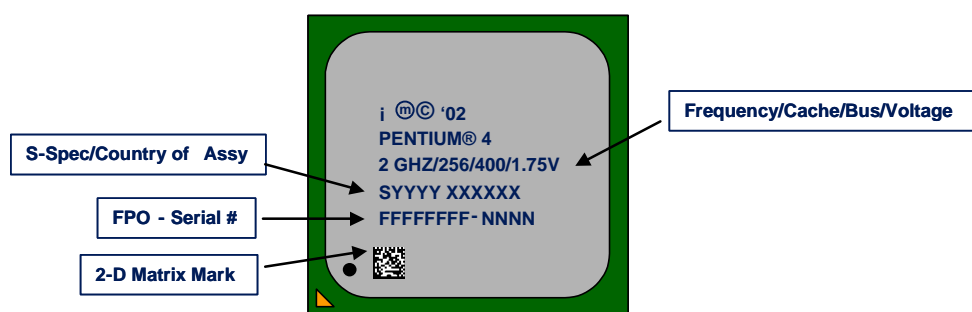
**Pentium 4 processor with 512-KB L2 cache on 0.13 micron process and boxed Pentium 4 processor with 512-KB L2 cache on 0.13 micron process processor markings**
